Space Mechanisms Lessons Learned Study

Volume II—Literature Review

Wilbur Shapiro, Frank Murray, and Roy Howarth
Mechanical Technology Incorporated
Latham, New York

September 1995

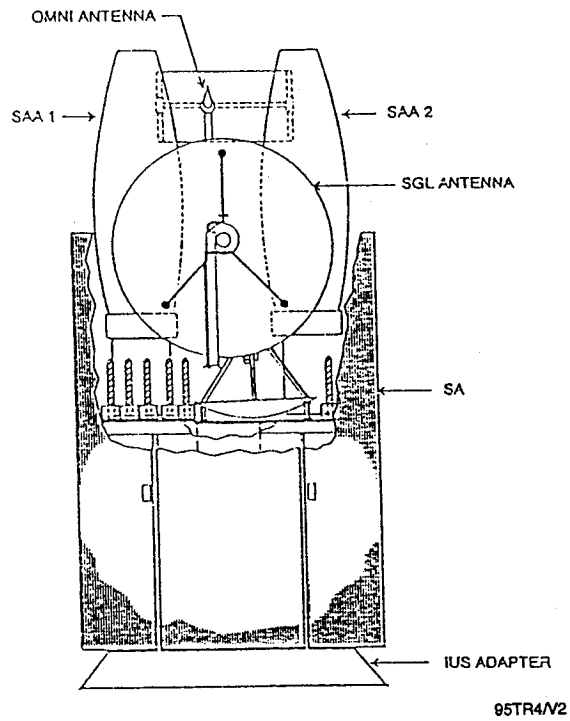
Figure 1. TDRS Stowed Configuration

The solar arrays consist of six large panels that form a hexagonal enclosure around the spacecraft body in the stowed configuration. Structurally, there are two separate solar array assemblies. Each assembly consists of a center panel and two outer panels.

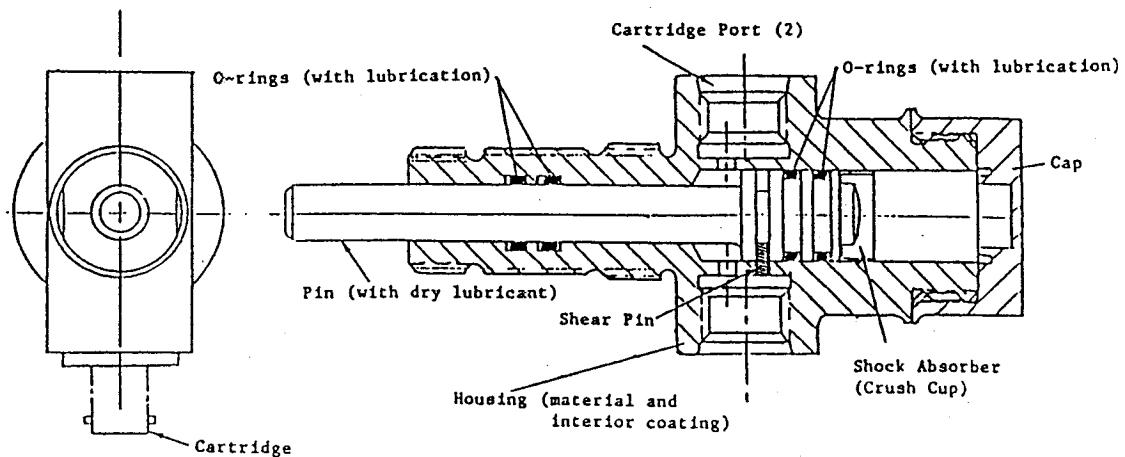
Figure 1. Viking Pin Puller

The Viking pin puller releases an antenna on the mission's Mars Lander. Its design and system variables are shown in Figure 1. Firing either cartridge first fails the shear pin and drives the piston from left to right to withdraw the pin. The pin puller was inconsistent and failed.

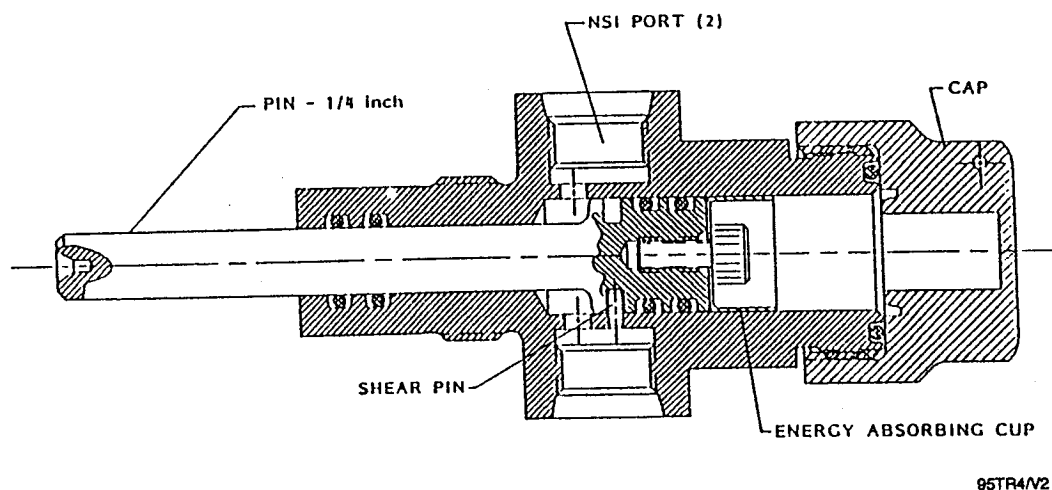
Figure 1. Cross Section of Steel-Bodied Halogen Occultation Experiment Pin Puller

The Viking application was to release an antenna on the surface of Mars, and the halogen occultation experiment application was to release a gimbal interface in Earth orbit. Both pin pullers had the same basic design: a 0.25-in. diameter pin was withdrawn just over 0.5 in. by firing either of two cartridges. The cartridge output vented through a 0.100-in. diameter opening out of the port to pressurize the pin side of the piston. The shear pin failed at approximately 80-lb static force. Redundant O-rings were used on both the pin and the piston and lubricated with medium-consistency silicone grease. A deep-drawn, 0.15-in. long, 0.010-in. wall thickness, 302 stainless steel energy-absorbing cup (see Figure 1) crushed on impact into the cap to remove the excess energy from the pin-piston and prevent rebound.

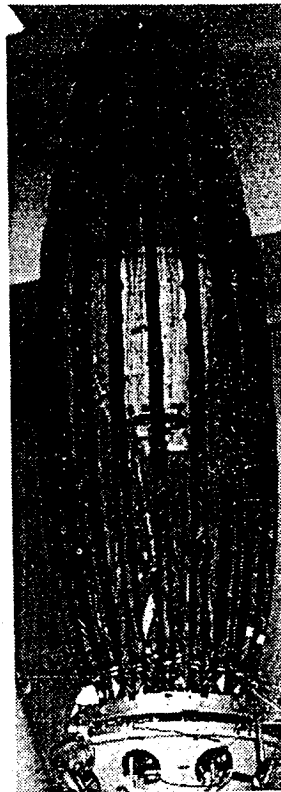
Figure 1. Galileo Spacecraft Configuration

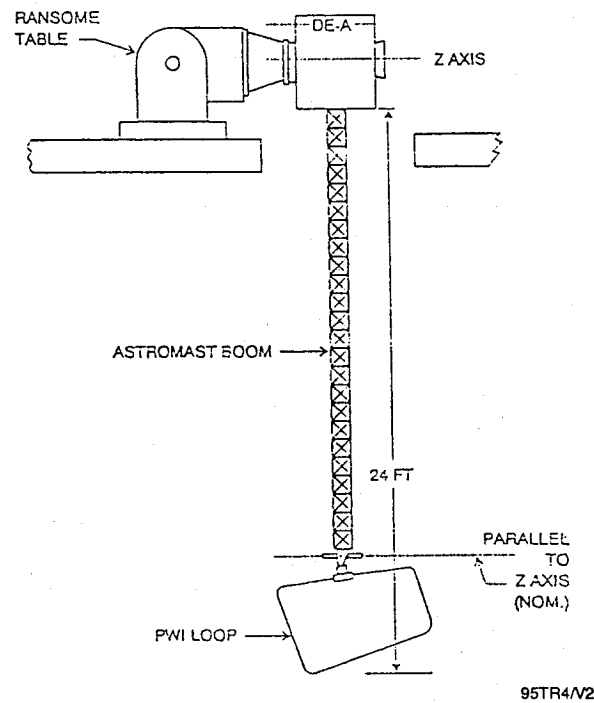
Figure 3. Astromast Deployment Configuration

Dynamics Explorer Astromast. Two diametrically opposed Astromasts were deployed nearly simultaneously on the DE-A spacecraft. The deployment began at a spacecraft spin rate of approximately 25 rev/min. It took place in several steps, with a spin-up maneuver occurring at some intermediate position. Each Astromast achieved its full length of 20 ft at a spacecraft spin rate of 10 rev/min. The centrifugal acceleration experienced by the tip mass, tending to extend the Astromast, ranged between 0.5 g and 0.8 g, depending upon the spin rate and length of mast deployed. Final tip position and alignment were required to be within $\pm 0.2^\circ$ of nominal. The Astromast was caged for launch and pyrotechnically released for deployment. Since the coiled elements of the mast contained more than enough energy to effect deployment, a motor-driven lanyard was used to restrain and control the deployment and even retract it if desired.

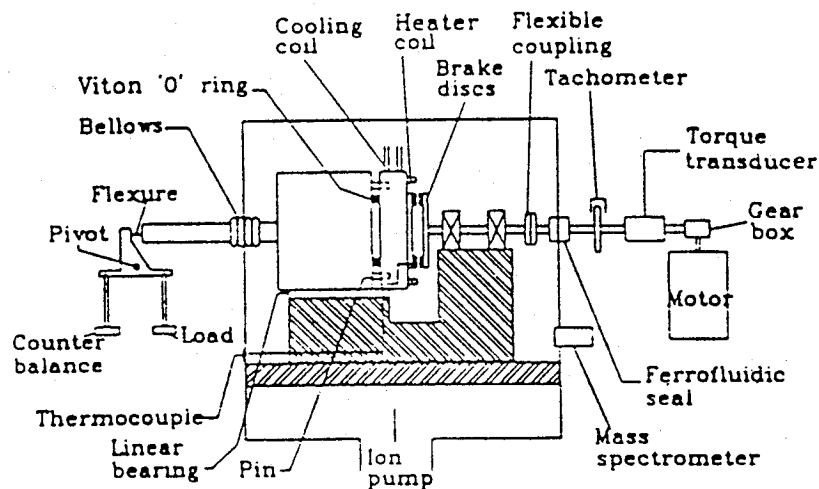
Figure 1 is a schematic of the test rig that was used. It was designed to provide an oil-free vacuum, below 1.3×10^{-4} Pa (10^{-6} torr). The friction and wear behavior of materials was determined from tests that involve continuous unidirectional, or reciprocating (60 sec clockwise, 10 sec off; 60 sec counterclockwise) sliding of one specimen versus another at 100 rpm with loads up to 70 N (bearing stress 0.14 MPa).

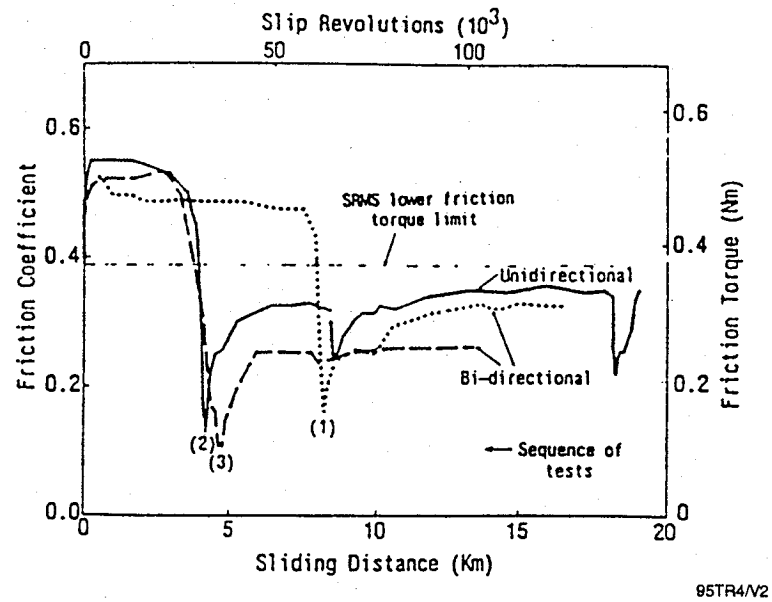
Figure 2. Friction Trends from Slipping of SRMS Brake Material in Vacuum

1. The low friction anomaly of the asbestos/phenolic is an inevitable consequence of its use in vacuum.
2. The friction in vacuum is determined by the residual moisture level and then by the structure and properties of the dry interfacial debris layer.
3. All polymers studied gave low friction through the development of minimal contact wear debris patches.
4. Ceramics can give a variety of frictional outputs, depending on the interfacial wear debris characteristics. Limited contact gives low friction, more extensive (matte) contact gives higher friction.
5. Some ceramics can be tailored by run-in to form finely distributed wear debris and to provide stable, high friction.
6. Some of the compositions that meet the No. 5 criteria may be useful for brakes in space.

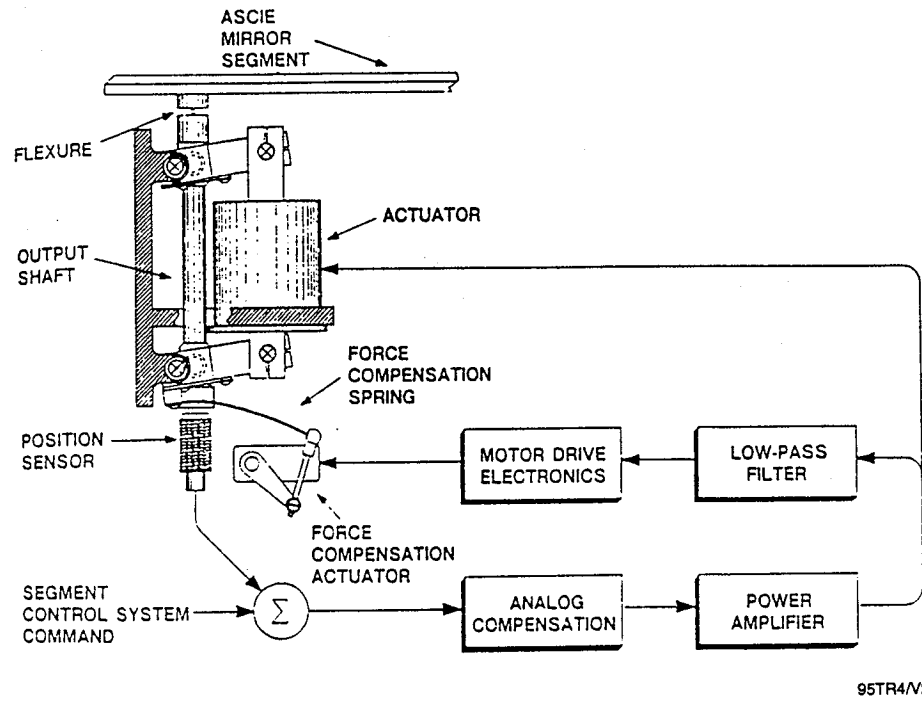
Figure 1. Lockheed Actuator and Closed-Loop Control System

Table 1 summarizes the approaches taken by the Lockheed design to overcome the limitations of conventional designs. Table 2 compares the performance of the Lockheed actuator design with other actuators that have been used or proposed. Table 3 lists the performance characteristics of the Lockheed actuator.

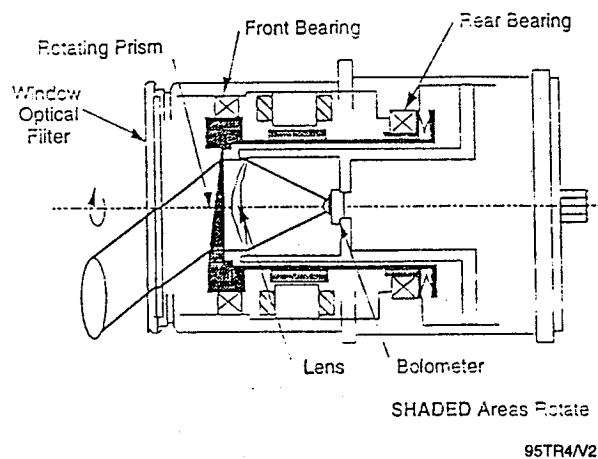
Figure 2. Sensor Head Layout

Light enters the front of the sensor head through an optical band-pass filter on the front window. The desired infrared energy passing through the window is deflected 45° by a prism and then focused onto the detector. A motor rotates the prism which causes the sensor head line of sight to sweep a 45° half apex angle scan cone in space. The sensor head preamplifier magnifies the detector signal and sends it to an external electronics assembly. This signal, along with rotor position information, is used to generate pulse width and phase (roll and pitch) information for use by the spacecraft for attitude determination. The motor rotor/prism is suspended on two angular contact ball bearings, preloaded by a spring. A hollow shaft motor is required to afford space for the optics and the infrared sensor. This requires the use of relatively large diameter bearings.

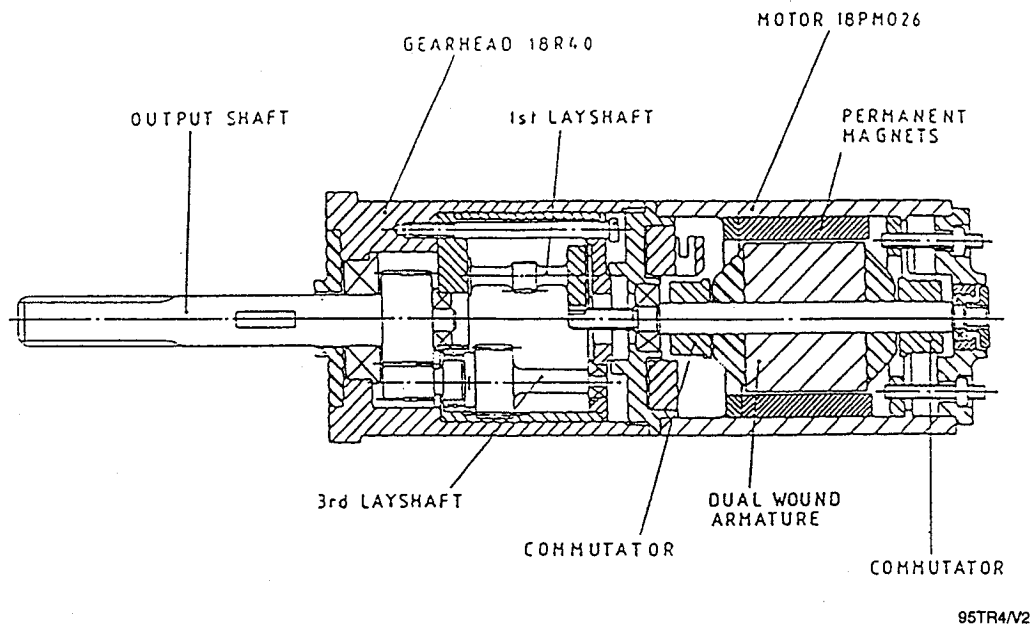
Figure 1. Dual-Wound Motor Gearhead (Section View)
(Note: Second Layout Omitted for Clarity)

Two ceramic magnets are bonded to the stainless steel housing. They are made of barium ferrite and was chosen because it has a good resistance to demagnetization. This permits the rotor to be removed and replaced without affecting the performance. Although the magnetic characteristics of the material exhibit a knee in the BH curve, it is not possible to demagnetize the motor under normal operations or by reversing the motor while running at ambient temperature.

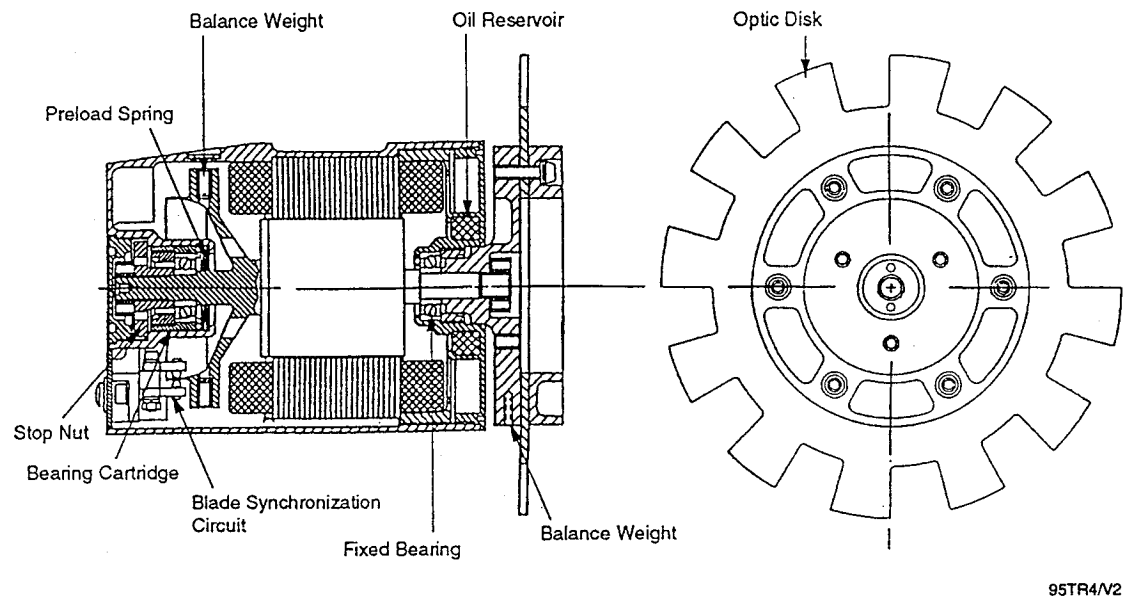
Figure 1. Optical Chopper Assembly Cross Section

After assembly, the optical chopper assembly was shipped to the Jet Propulsion Laboratory (JPL) for integration and system testing. These tests showed that the bearing power loss was greater than the 1 W specified. However, the motor efficiency was higher than predicted and the system was acceptable. The higher power loss in the bearings could be due to excess lubricant or misalignment. The bearing power loss is very sensitive to the amount of lubricant present and, from observations during the tests, it appears that this was the probable cause for the anomaly.

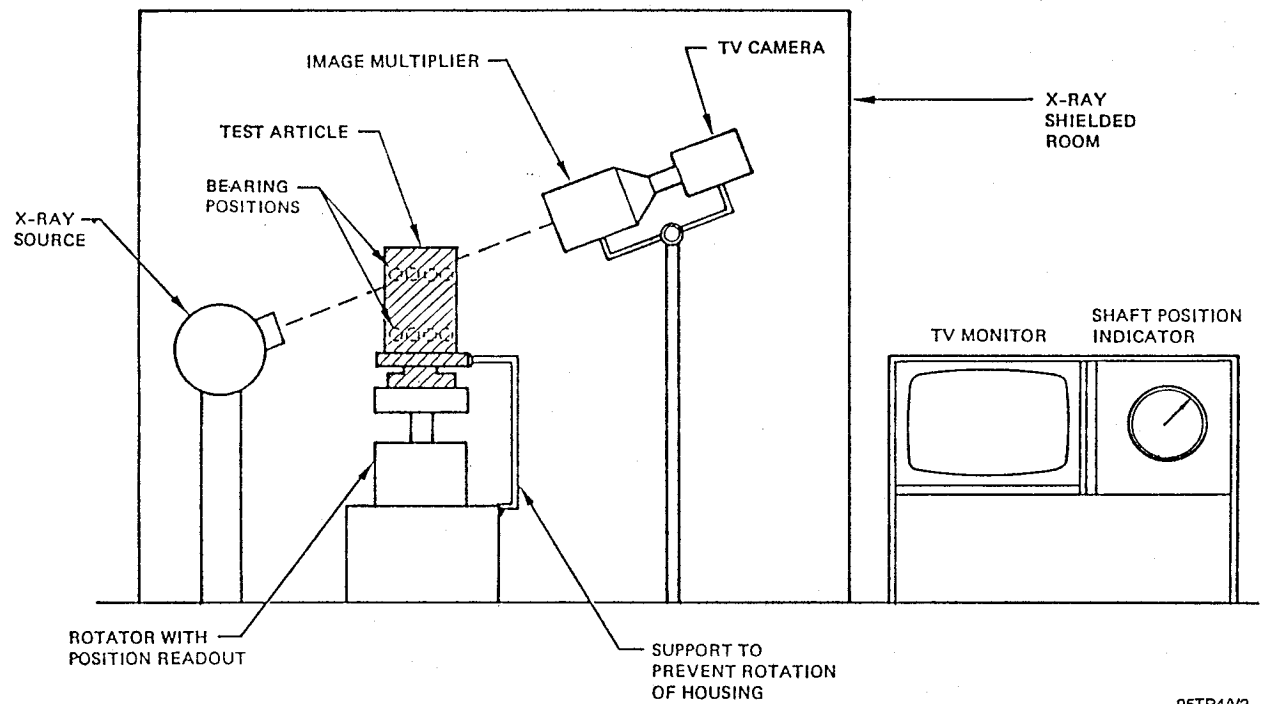
Figure 1. Measurement System

The contact angle accuracy improves with increased ball count. With the values above, counting 300 balls the contact angle will be accurate to approximately $\pm 0.2^\circ$. Increasing the ball count to 700, the contact angle will be accurate to approximately $\pm 0.1^\circ$.

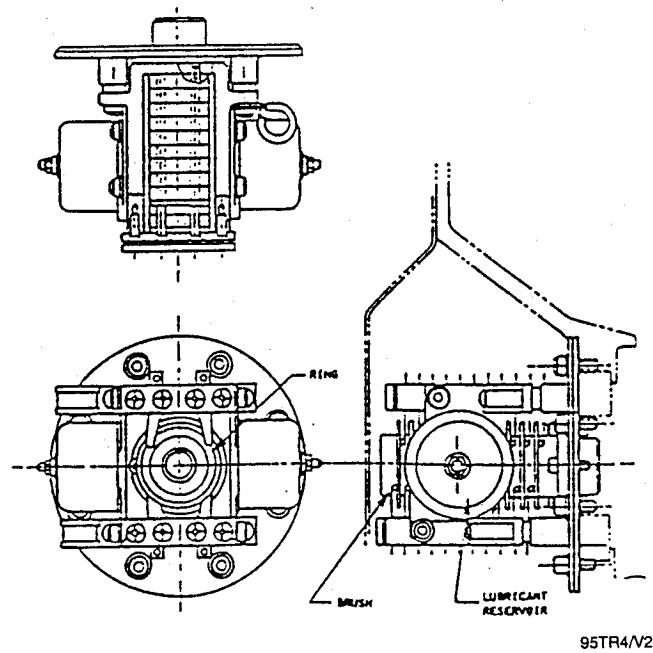
Figure 1. OSO-6 Slip Ring Assembly

Between 1962 and 1969, six OSOs were flown accumulating a total of more than 18 yr of operating time before shutdown. With the despin drive turned off during orbit night, about 200 million drive revolutions or 3 billion slip ring revolutions were accumulated with no known slip ring problems. One of these units with its tiny brushes operated at 30 rpm for more than five years (60 min on, 30 min off) in OSO-5. One contributing factor was the effectiveness of the lubricating oil (used to replace the effectiveness of water vapor in air for terrestrial applications) and the wear mechanism that this oil helped to promote. A small amount of brush wear, generated during early operation, remained under the brush pad and provided additional lubrication, effectively eliminating further wear.

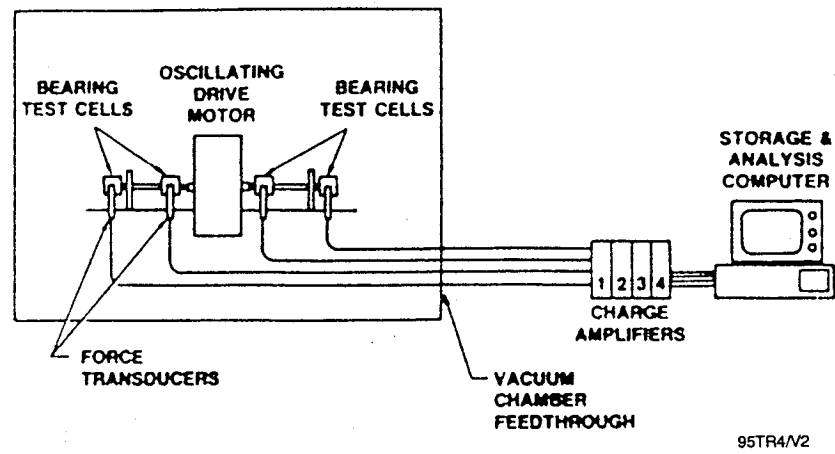
Figure 1. Bearing Test Facility

Test Conditions. The scanner simulator was oscillated through an arc of +57° at a frequency of about 6 Hz. Each duplex pair of bearings had a preload of 13.4 + 2.2 N. The bearing test facility was mounted in a vacuum test chamber that was evacuated to a vacuum of about $<1.3 \times 10^{-6}$ Pa (-10 torr).

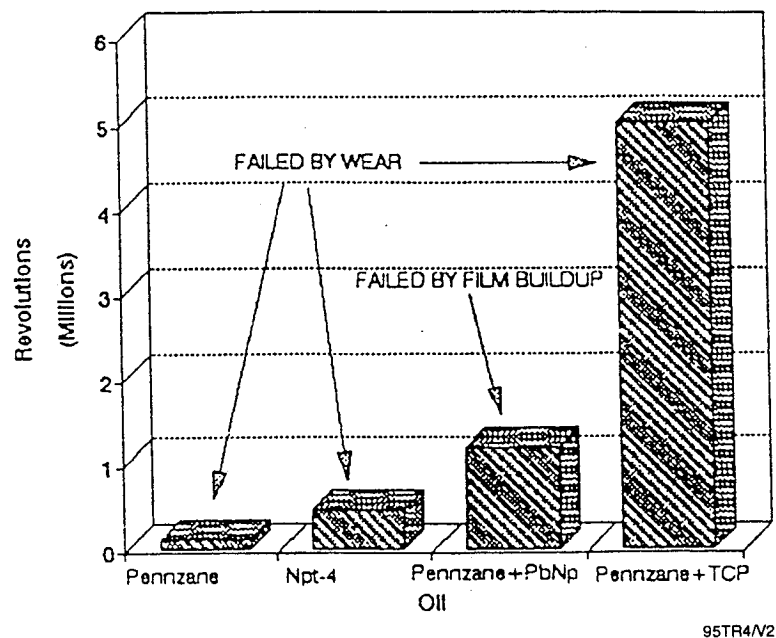
Figure 2. Screening Test Results (Harmonic Drive)

Following the screening tests, the surfaces of the test specimens were analyzed with energy-dispersive x-ray and/or Auger electron spectroscopy. This revealed that the bearings lubricated with TCP and PbNp containing oils failed by different mechanisms. The bearings lubricated by Pennzane plus TCP failed by a wear process that involved surface distress and metal removal from the wear track. The bearing appeared to have failed at a point when the additive could no longer provide satisfactory boundary lubrication protection. In the bearing lubricated with Pennzane plus PbNp, there was no wear. Instead, the increased friction appeared to have been caused by the formation of a tough, lead-containing carbon film on the surface of the disk. These apparent differences suggest that the two additives cannot be directly compared. The surface film generated by PbNp would make it suitable for high-stress applications where maximum protection against wear is desired and increased friction is not a factor. On the other hand, TCP would be more suited to light or intermediate loads, where low friction and long life are desired. For the harmonic drive, low friction is not as important as wear protection. Based on this, Pennzane would be the best combination. Life tests on harmonic drive mechanisms with NPT-4 and Pennzane plus PbNp confirmed the results of the screening tests.

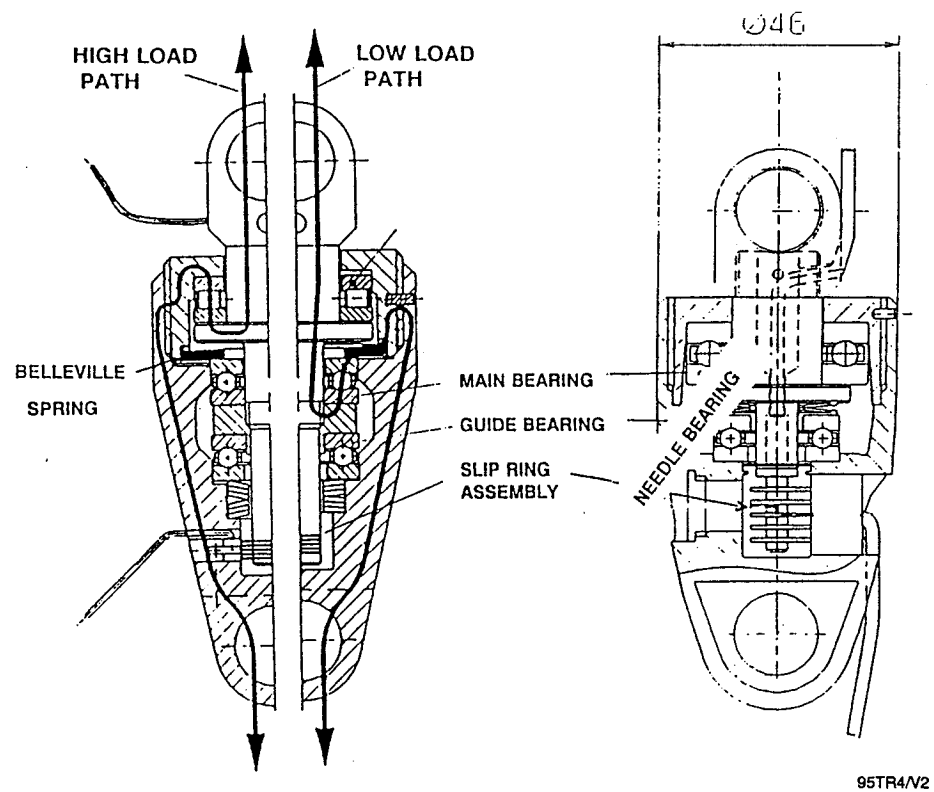
Figure 4. Parachute Swivel Mechanism Baseline Design

- Outer diameter: 46 mm
- Length: 120 mm
- Mass: 38 gm.

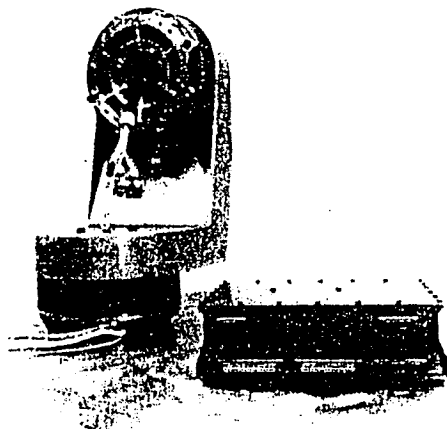
This is mounted on the stationary flange of the actuator, and connects to the moving flange by a two-pass gearbox with a total ratio of 32. The first pass is a bevel gear with a ratio of 4:1, and the second pass is a spur pinion driven by the same ring gear that is driven by the motor gearbox, with a ratio of 8:1 (see Figure 7). The gears carry negligible load and are cut from stainless steel, unhardened, but with the same lubricants as the motor gears.

Figure 2. Flight Model Hemispherical Pointing Mechanism and Control Electronics
